# EQUIPMENT INTERCHANGE REPORT — CONTAINER INSPECTION

Document  
**EIR-82JZ9U4X6X**

| Container no.<br><b>HANU8374480</b> | Size<br><b>Not stated</b> | Type<br><b>Not stated</b> | ISO code<br><b>Not stated</b> |

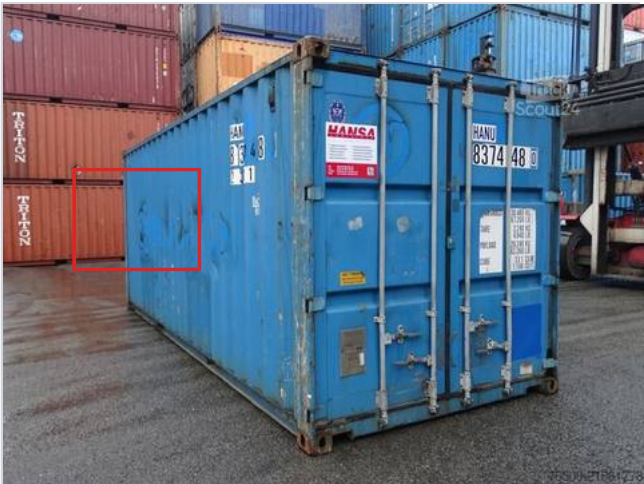
p1 - area outlined by Demo Inspector

1. DENT — LEFT\_WALL

MODERATE · AI proposed

ORIGINAL AI OBSERVATION (UNEDITED)  
DENT — LEFT\_WALL · MODERATE · model confidence 0.90  
Abolladuras visibles en la estructura del panel lateral.  
INSPECTOR DECISION

#1 REPAIR\_REQUIRED (Demo Inspector, COMPANY\_ADMIN, 2026-08-19 14:51 UTC)  
REPAIR CODING  
Not coded — no repair coding catalogue is configured. No code or cost is stated.

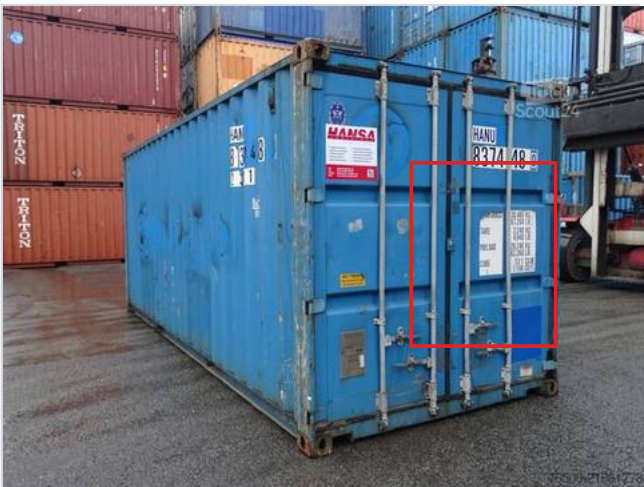
p1 - area outlined by Demo Inspector

2. DENT — DOORS

MINOR · AI proposed

ORIGINAL AI OBSERVATION (UNEDITED)  
DENT — DOORS · MINOR · model confidence 0.85  
Deformaciones leves en la superficie de las puertas.  
INSPECTOR DECISION

#1 OBSERVE (Demo Inspector, COMPANY\_ADMIN, 2026-08-19 14:52 UTC)  
REPAIR CODING  
Not coded — no repair coding catalogue is configured. No code or cost is stated.

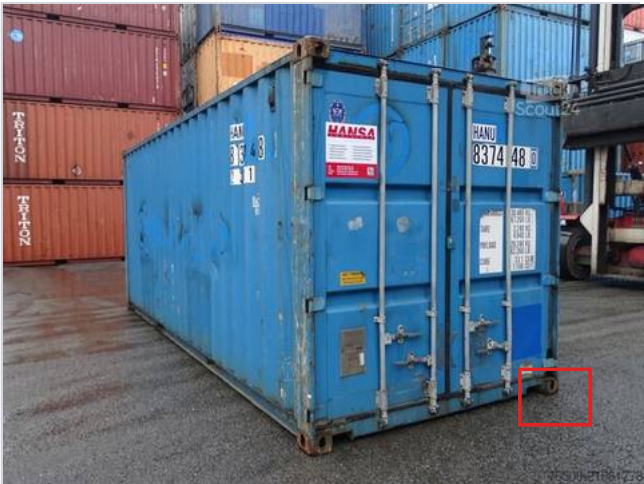
p1 - area outlined by Demo Inspector

ORIGINAL AI OBSERVATION (UNEDITED)  
CORROSION — CORNER\_CASTINGS · MINOR · model confidence 0.80  
Corrosión superficial en los elementos de la base.

#1 ACCEPTABLE (Demo Inspector, COMPANY\_ADMIN, 2026-08-19 14:52 UTC)
